T & M Associates, Inc. Engineers & Surveyors

January 24, 1994

RE: NORWICH SQUARE, NORWICH VERMONT
UNDERGROUND STORAGE TANK/CONTAMINATED SOIL REMOVAL
(T & M Project No. 405493)

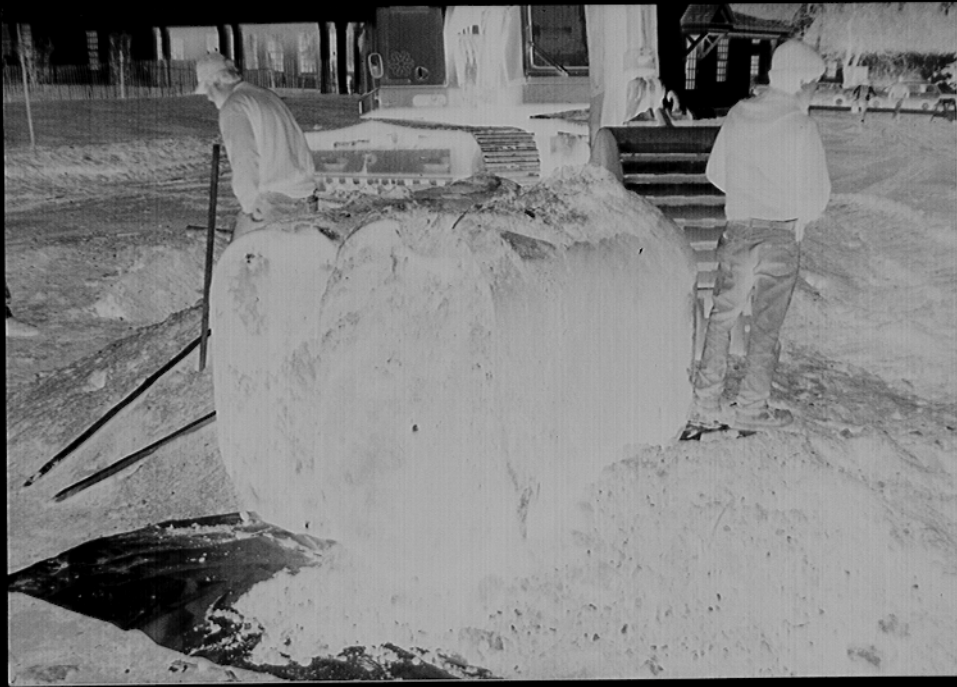
The two 275-gallon USTs were removed from the ground prior to Mr. Arey's arrival on-site. The photographs in Appendix B depict the tanks and the tank graves.

Our inspection of the tanks did not reveal any visual evidence of deterioration or perforations. It was apparent from the soil staining that a release had occurred from around the tank filler fitting area located at the top of the tanks. This release may have been a result of overfills or displacement of product by the introduction of surface water through the fittings at the top of the tanks. It is our understanding that the tanks were under a paved surface. We suspect that when the fill pipes were removed the protrusion through the pavement was not sealed. The top of the tanks was estimated to be approximately 6 inches below the pavement surface.

Norwich Square USTs November, 1993

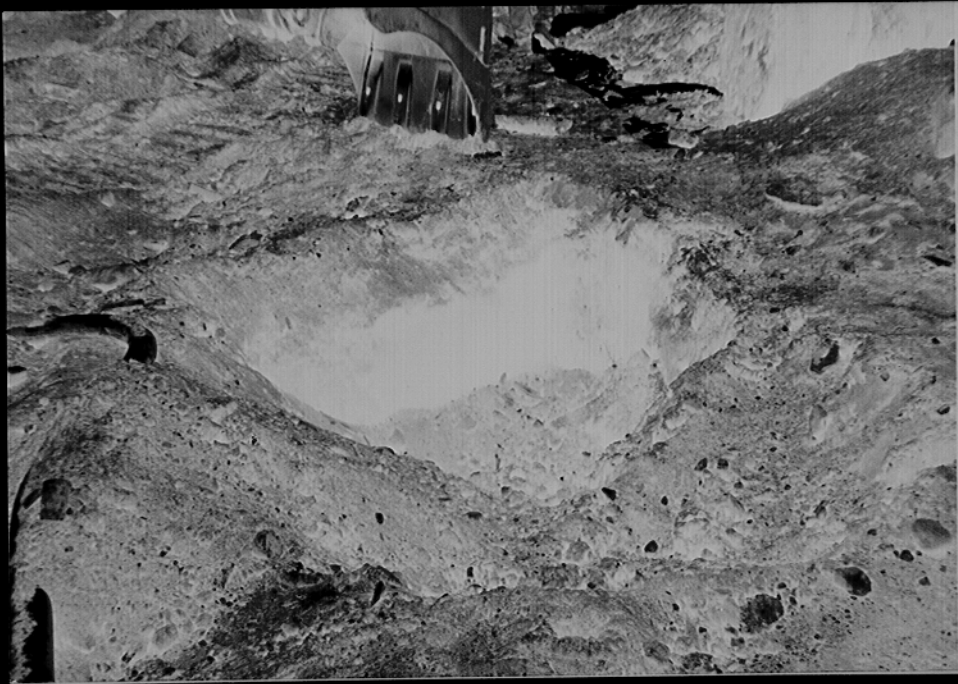
The release of a petroleum product was evident around most of the circumference of one of the tanks. The stained soils contained visible free product that resembled heavy petroleum. These saturated soils were up to 8" in thickness.

The visibly-contaminated soils were excavated from the tank grave area and stockpiled on plastic. A Thermo Environmental Instrument Model 580B organic vapor meter (OVM) with a 10.6 eV lamp field calibrated against an isobutylene standard was used to further screen the remaining soils for removal. Approximately 14 cubic yards of contaminated soils were eventually excavated from the tank grave. The entire disturbed area was approximately 10' x 10' by 6' deep.

OVM screening of soil surrounding the tanks revealed a peak reading of 27 ppm along the side wall of the westerly tank. Soils were excavated until the OVM readings were less than 1 ppm.

Norwich Square Tank Grave
Note Stained Soils on Side Walls

Three soil samples were collected from the tank grave after removal of contaminated material. Two were composite samples along the side walls of the tanks. The third sample was a composite soil sample from beneath each of the tanks. The samples were collected in 250 ml glass containers with teflon covers, packaged on ice and shipped via United Parcel Service to Aquarian Analytical, Inc. located in Canterbury, New Hampshire. The samples were analyzed for volatile organic compounds by EPA Method 8240 and for total petroleum hydrocarbons (TPH) by EPA Method 418. The laboratory reports included as Appendix C and are summarized in the following table. Soil sample SS-1 is a composite sample from the side walls of the westerly tank, while SS-2 is a composite from the side walls from the easterly tank. SS-3 is a composite sample from beneath the two tanks.
